# **INDOOR AIR QUALITY ASSESSMENT**

**Leicester Memorial Elementary School  
11 Memorial School Drive  
Leicester, MA 01524**

Prepared by:  
Massachusetts Department of Public Health  
Center for Environmental Health  
Emergency Response/Indoor Air Quality Program  
May, 2005

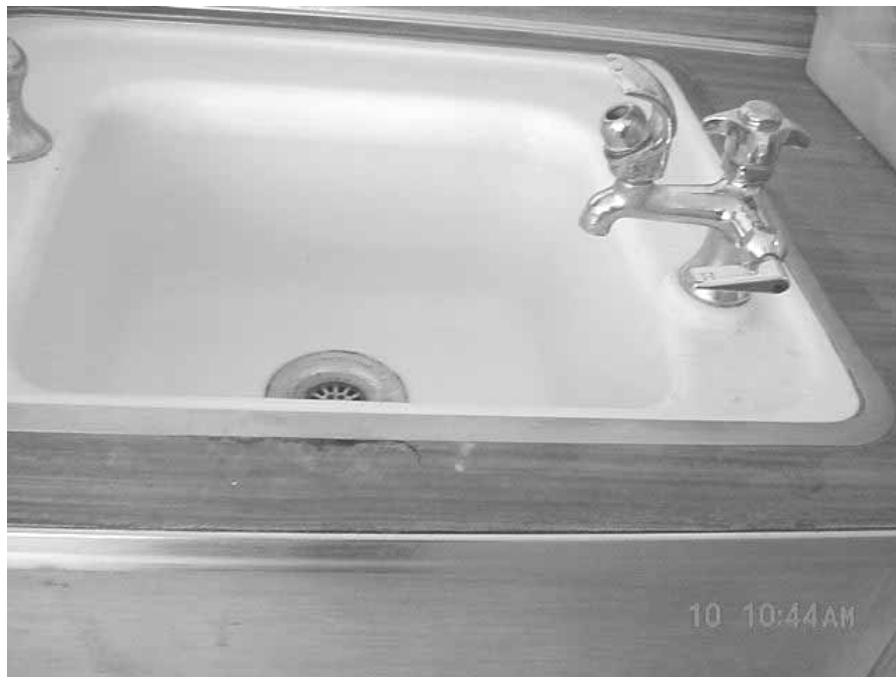
Picture 12

Other areas of potential mold growth were observed. Open seams between the sink countertop and wall were observed in several rooms. If sink countertops are not watertight, moisture can penetrate through the seams, causing water damage. For example, a clapboard countertop was noted to be swelling (Picture 12). Water penetration and chronic exposure of porous and wood-based materials can cause these materials to swell and show signs of water damage. As discussed above, moistened materials that are not dried within 24 to 48 hours can become potential sources for mold growth.
